UNDERWATER BRIDGE INSPECTION REPORT

STRUCTURE NO. L9465

EAST FORK OF THE RAPID RIVER

DISTRICT 1 - KOOCHICHING COUNTY

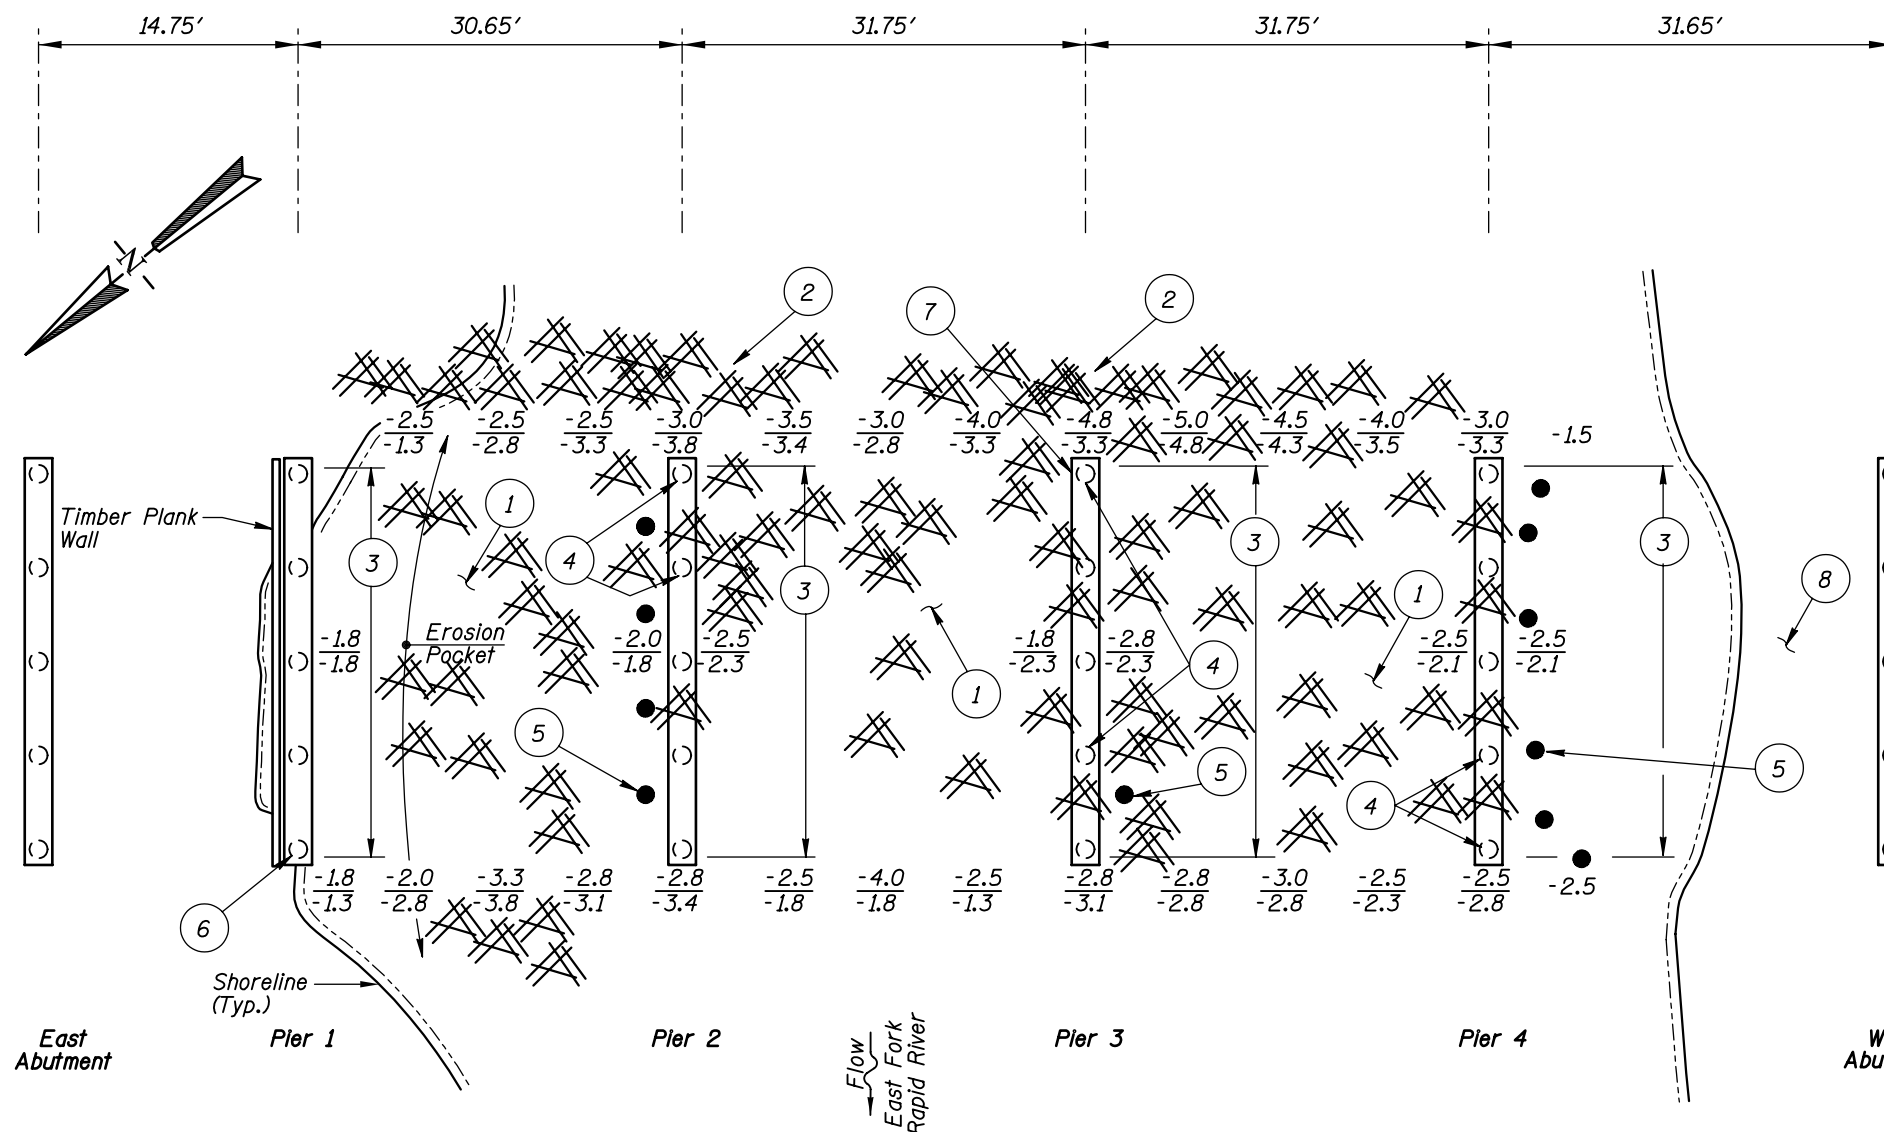
INSPECTION AND SOUNDING PLAN

- The channel bottom consisted of approximately 1 foot of soft organic material and twigs overlaying a firm silty clay with probe rod penetrations of 3 inches.

- Moderate to heavy accumulation of timber debris was observed along and between Piers 1 through 4, and in the channel upstream of the piers extending 100 feet upstream. The debris has restricted the channel flow causing increased flow and erosion pocket to form in the channel to the west of Pier 1.

- Minor deterioration was randomly observed on all timber piles consisting of weathering and 1/8 to 1/4 inch wide checking.
- Above water, especially near their tops, indicated piles exhibited heavier checking and splitting from 1/2 to 1 inch wide with a maximum penetration of half the pile diameter.

- Piles cut off above the waterline were observed typically extending 1 foot above the waterline with some extending up to the pile cap.
- Moderate deterioration along a 2 inch wide strip from mudline to 2 feet above waterline, with 1/2 inch penetration and another 1 inch of soft wood.

- The cross bracing was damaged and no longer connected to the upstream pile of Pier 3.
- Erosion of shoreline was observed along the west shoreline. However, the shoreline armour consisted of 3 feet diameter riprap was still in place along the shoreline.

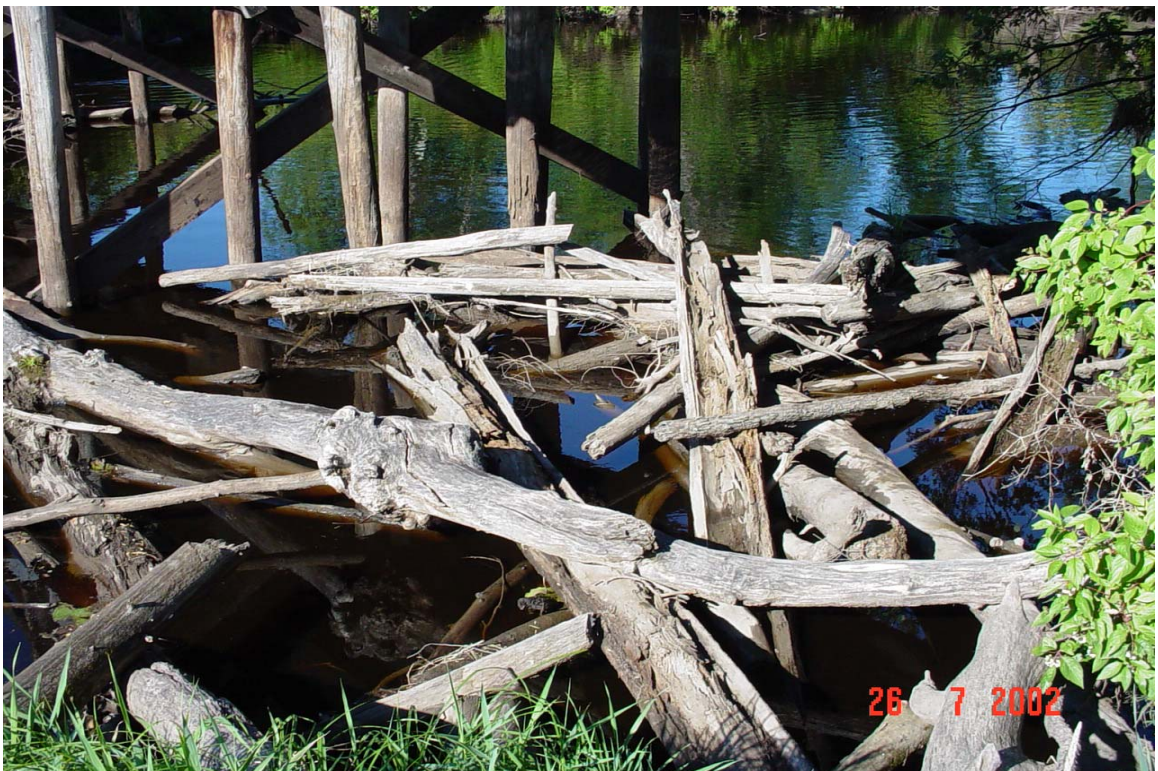
Photograph 6. View of Timber Debris Between Piers 1 and 2, Looking Southwest.

- (A) Remove the moderate to heavy accumulation of timber debris at Piers 1 through 4 and between the spans to eliminate the potential for continued accumulation, scour influence, and excessive lateral loads on bridge.
- (B) Repair the damaged crossbrace and connection at upstream pile of Pier 3.
- (C) Reinspect the submerged substructure units at the normal maximum recommended (NBIS) interval of five (5) years.

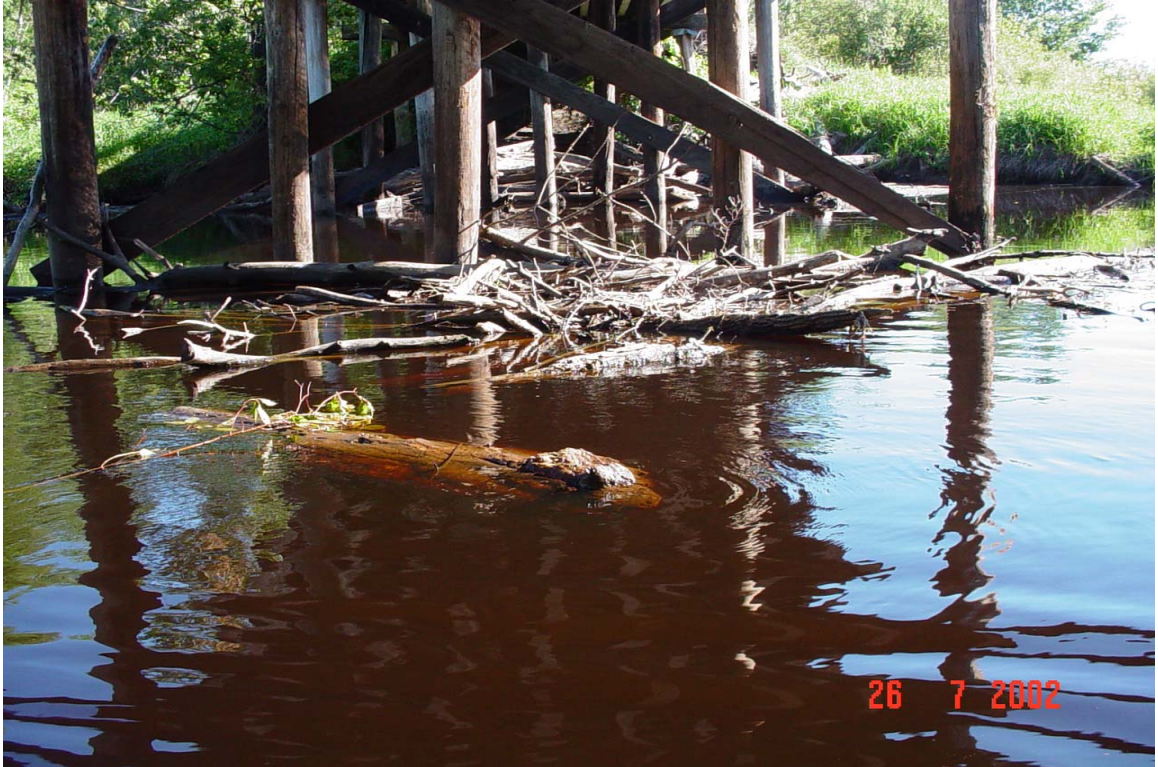
Photograph 7. View of Timber Debris at Pier 3, Looking North.

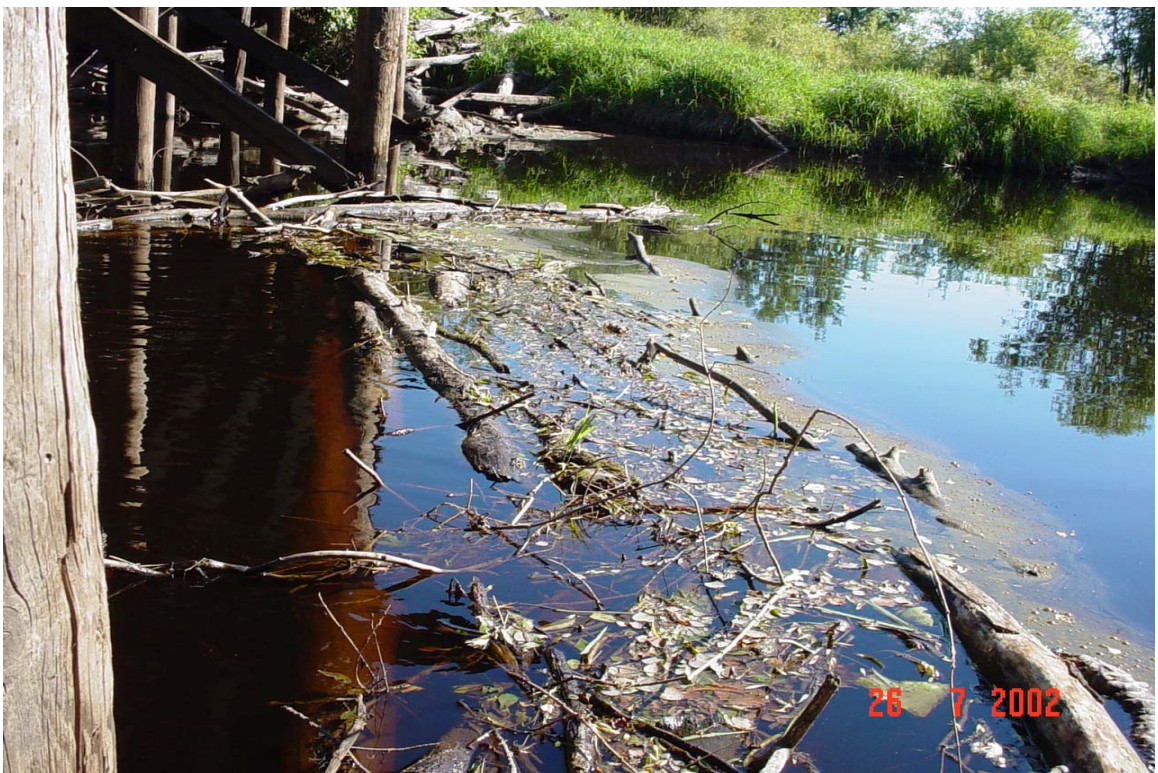
Photograph 8. View of Timber Debris Between Piers 3 and 4, Looking North.

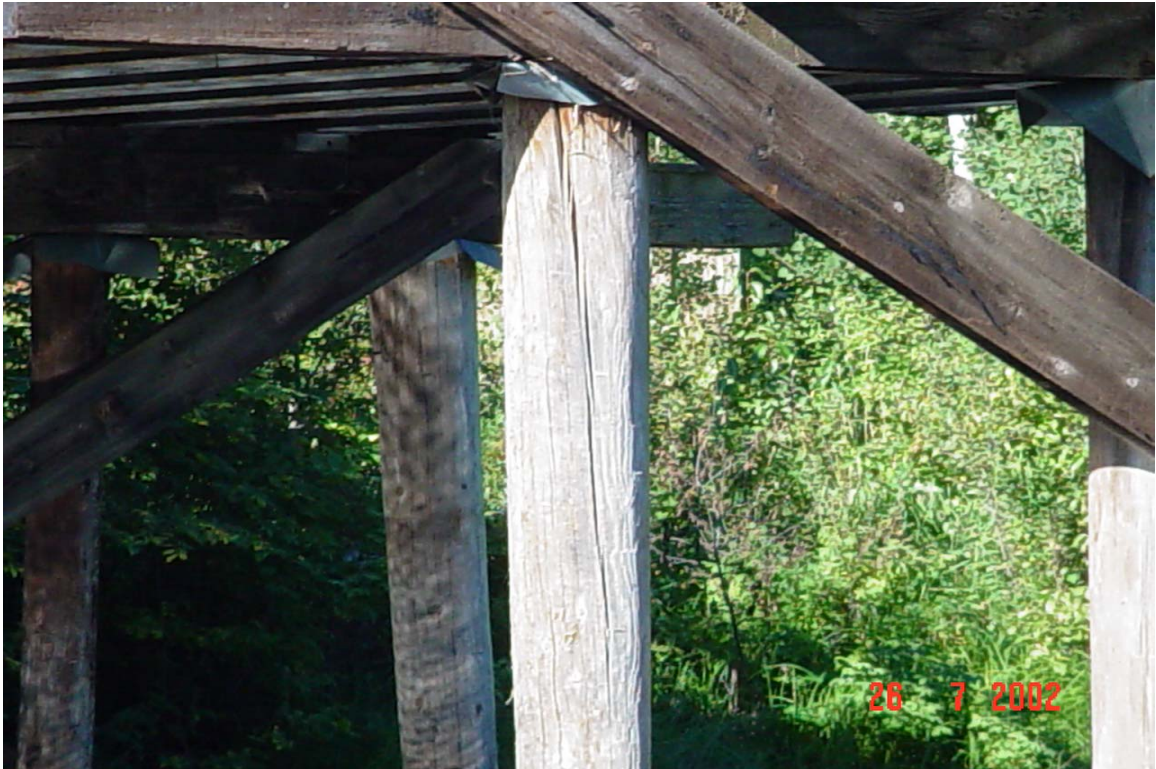
Photograph 9. View of Typical Larger Splitting/Checking at Top of Piles, Looking Southwest.

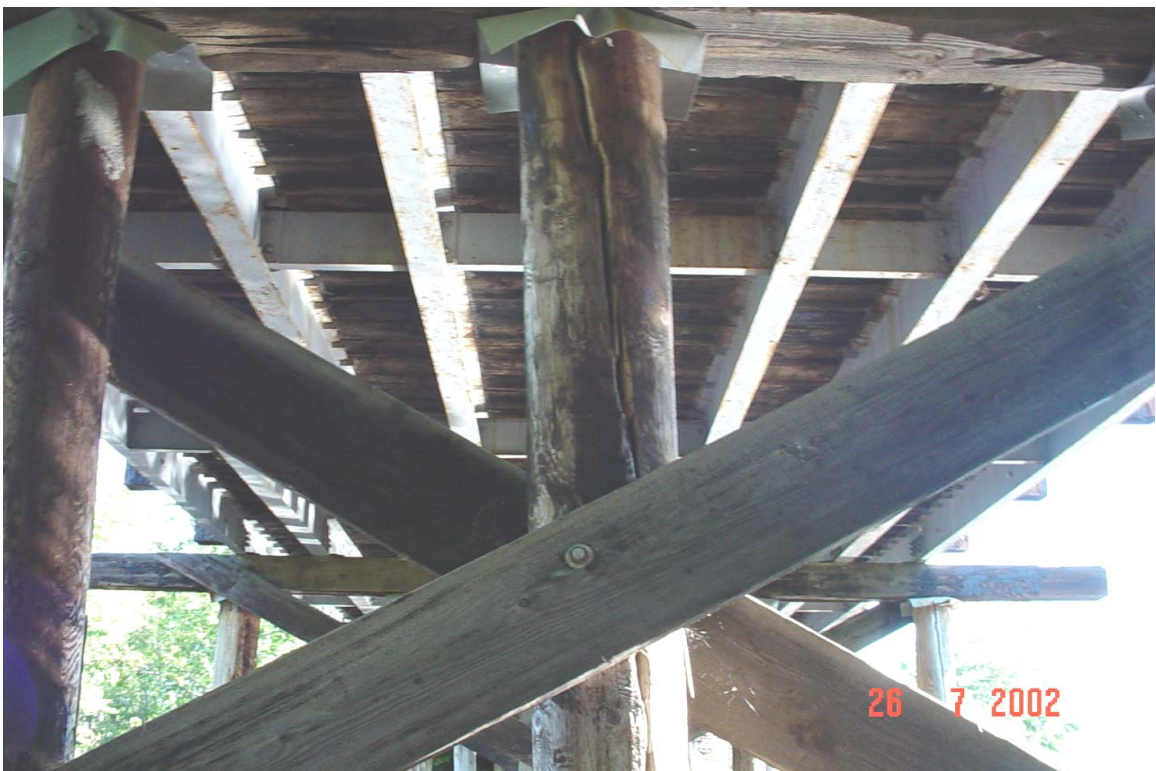
Photograph 10. View of 1" Wide Split at the Top of the Center Pile of Pier 4, Looking North.

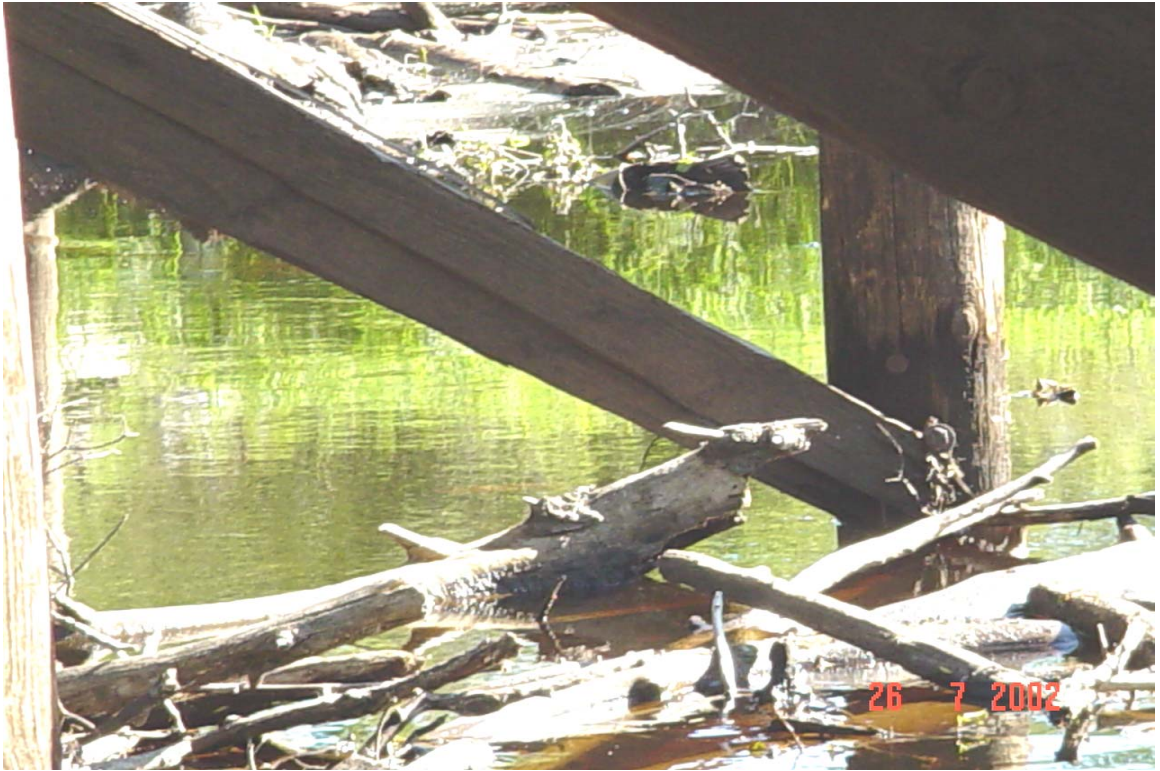
Photograph 11. View of Damaged Crossbrace and Connection at Upstream Pile of Pier 3.
